# Manhole Inspection Summary

Manhole # S23II1026MH

Insp Date: **11/22/06 9:29 AM**

**Location** Address: **4220 ROLAND HEIGHTS AVE** Cross Street: **NEWPORT AVE**

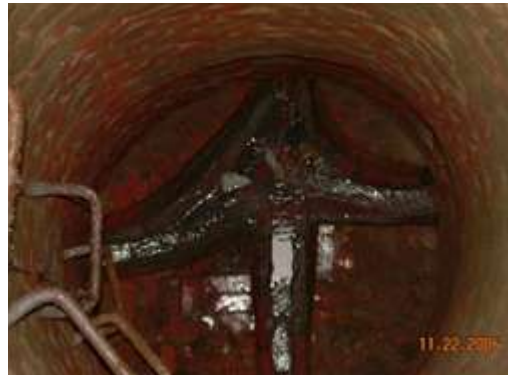
Top View

Corroded steps. Bench and Channel debris.

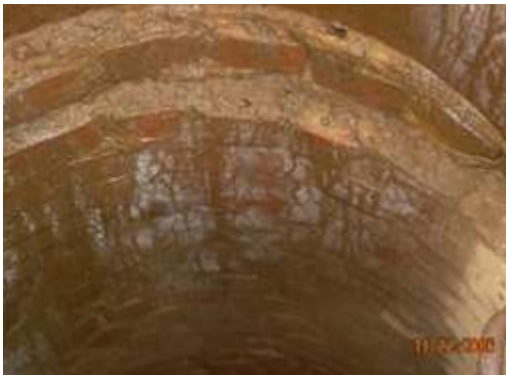
Defect

Frame leaks. Adjustment deterioration and infiltration.

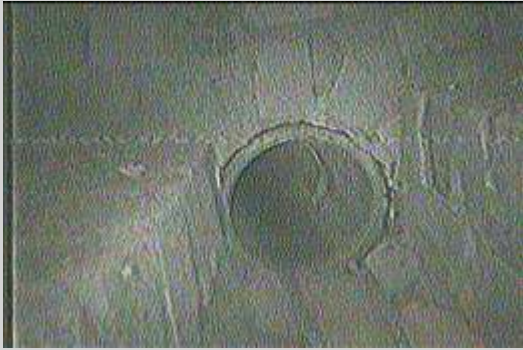
### 6 in. Circular Gravity Sewer

Infiltration: **Evidence** Pipe Seal Cond: **Unknown**

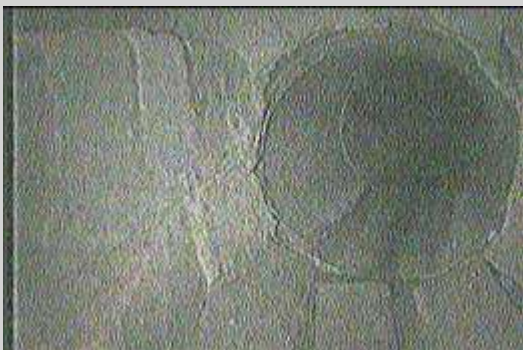
### 8 in. Circular Gravity Sewer

Infiltration: **Evidence** Pipe Seal Cond: **Cracked**
